DAILY REPORT

PROJECT	San Jacinto River Waste Pits TCRA	CONTRACT NO.	
CONTRACTOR	USA Environment, LP	SUPERINTENDENT	Ron Griffith
DAY OF WEEK & DATE:	Wednesday, May 18, 2011	REPORT NO.	106
WEATHER	Mostly cloudy, moderate wind from southeast	TEMPERATURE	L:65° H:85°F
<u>NUMBER/CLASS OF CONTRACTOR'S PERSONNEL:</u>		<u>MAJOR EQUIPMENT ON JOB (Size/capacity):</u>	
10 – USA Environment (USA) 10 – Shirley & Sons 2 – Chris Ransome & Associates (CRA)		LaBarge Property Komatsu PC300LC Excavator (2) Komatsu PC200LC Excavator Komatsu D61 Dozer Deere 624J Front-end Loader Deere 644J Front-end Loader Crane Work boat with winch TxDOT ROW/SJRWP Cat Long Reach Excavator Cat 930 Loader Cat D5 Dozer Morooka Dump Truck Water Truck Barge-Mounted Excavator (2) 'Jim Dandy' Tug Boat Jon Boat Aggregate Transport Barge	
<u>TIDE INFORMATION:</u>		<u>HEALTH AND SAFETY INFORMATION:</u>	
Time: 09:30	Location: SG-03	Height (inches): 16½	No incidents or near misses on this date.

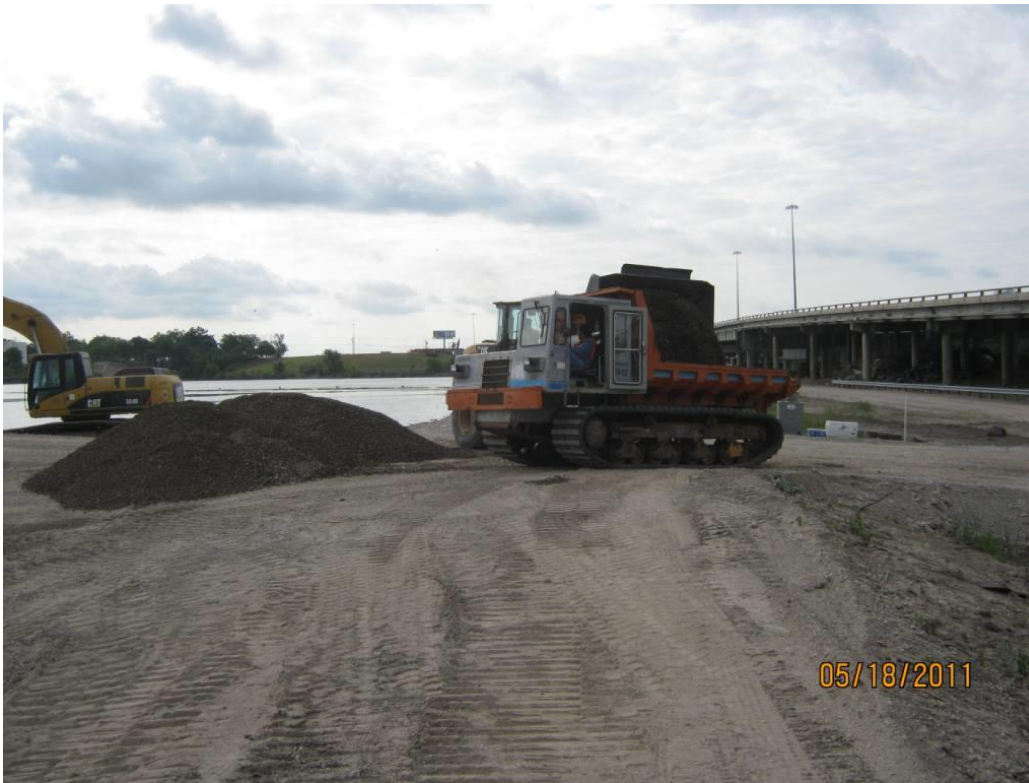
Photo 1 – Loading low-ground pressure Morooka truck with crushed concrete road base.

- Front-end loader placing CCRB onto a low ground pressure Morooka dump truck

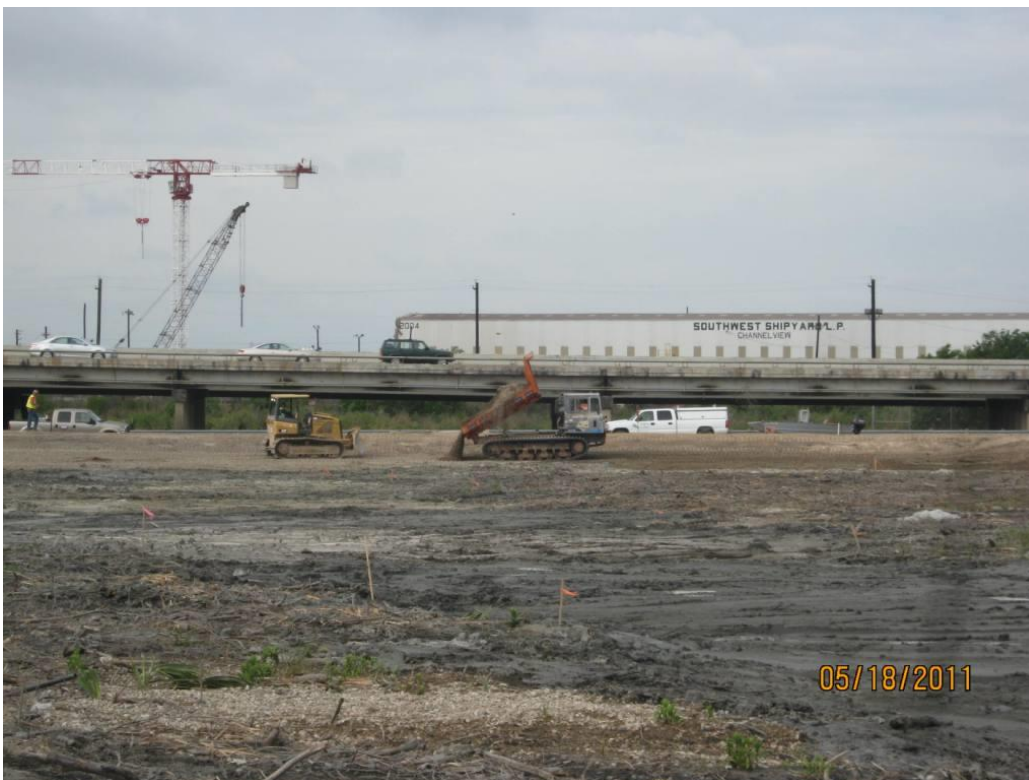
Photo 2 – Morooka truck unloading crushed concrete road base in the Western Cell.

- Morooka truck delivering CCRB near the leading edge of the CCRB placement area, traveling on previously-placed CCRB material
- Dozer spreading CCRB across the surface of the Western Cell, tracking on previously placed CCRB material

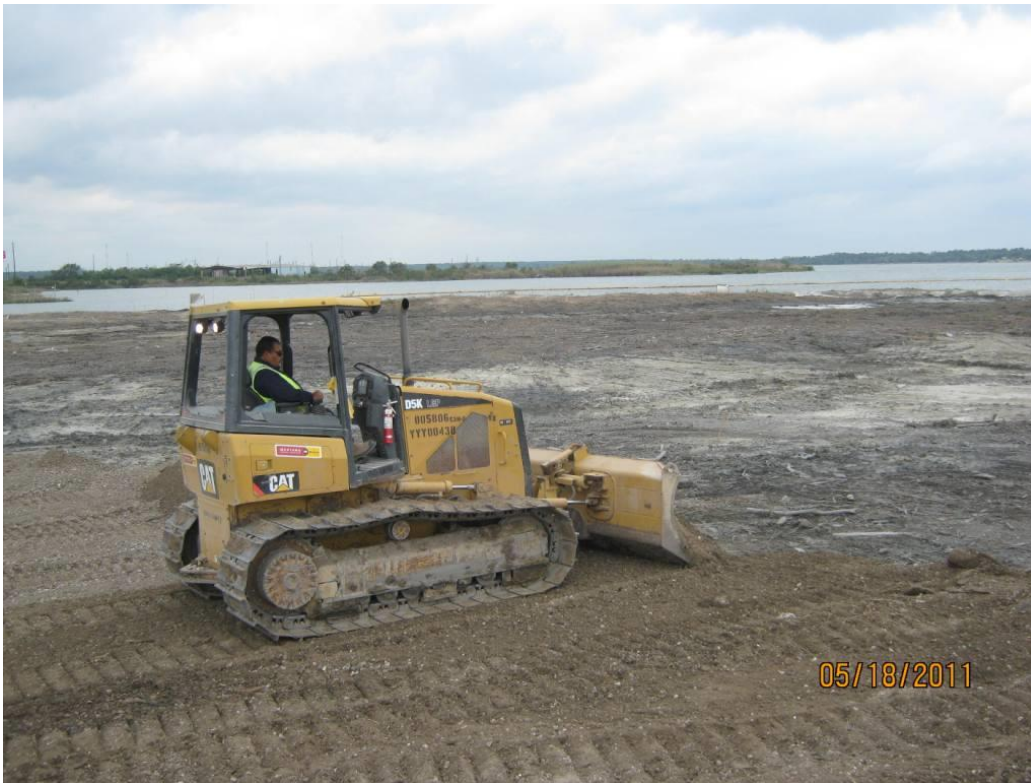
Photo 3 – Dozer spreading crushed concrete road base in the Western Cell to create a smoothly-graded surface.

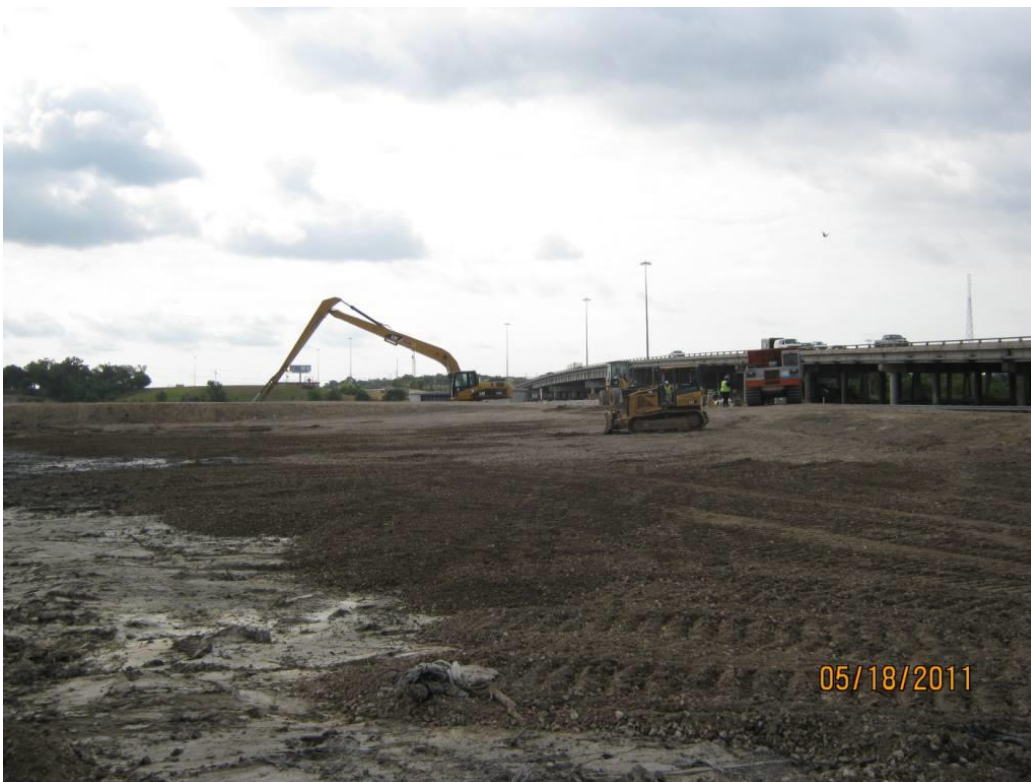
Photo 4 – Overview of surface-grading operations in the Western Cell.

- Decontaminating JCB long-reach excavator
 - Surface grading in the Western Cell, using the following procedure:
 - Receiving CCRB at the south end of the central berm

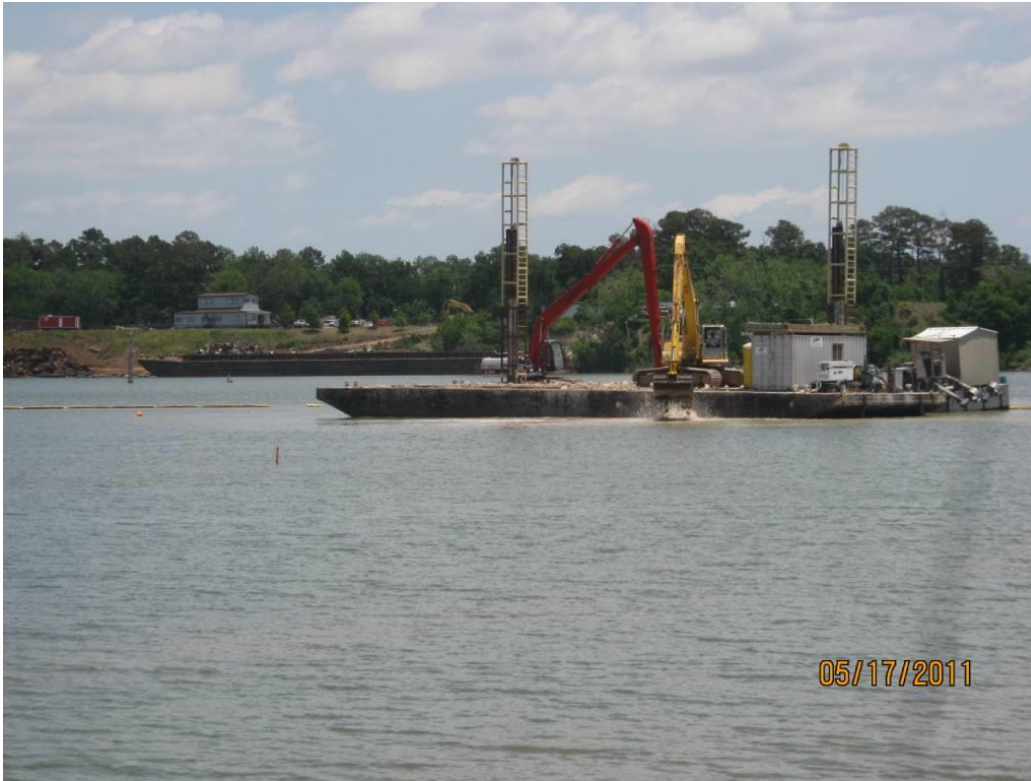
Photo 5 – Placing Armor Cap D rock in the Eastern Cell.

- Completed placement of the armored cap in the Eastern Cell, pending potential areas of re-work to be identified by a comprehensive hydrographic survey (water-based operations)
- Received 676 tons of CCRB and used the CCRB to grade the surface of the Western Cell

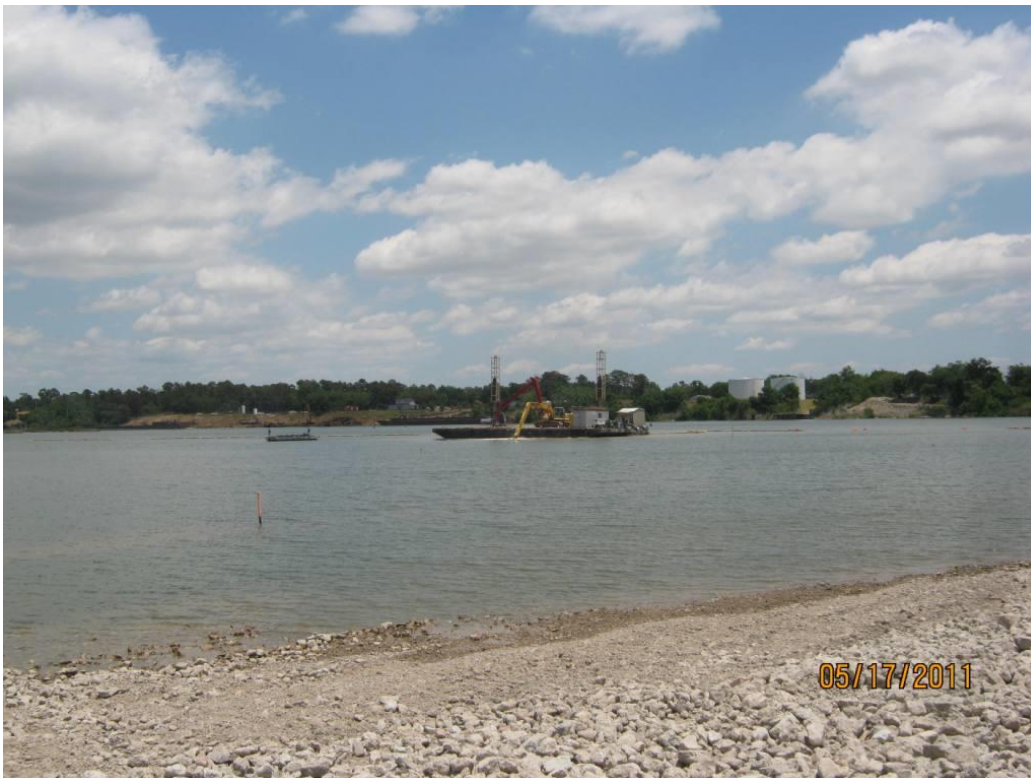
Photo 6 – Using excavator bucket to measure the thickness of Armor Cap D placement in the Eastern Cell.
